STATE OF CALIFORNIA  
DEPARTMENT OF PUBLIC WORKS  
DIVISION OF HIGHWAYS

CUT SLOPE DESIGN AND LANDSLIDES  
SOME CASE HISTORIES

T. W. Smith and H. R. Cedergren

Prepared for  
A.S.T.M. Meeting  
Los Angeles

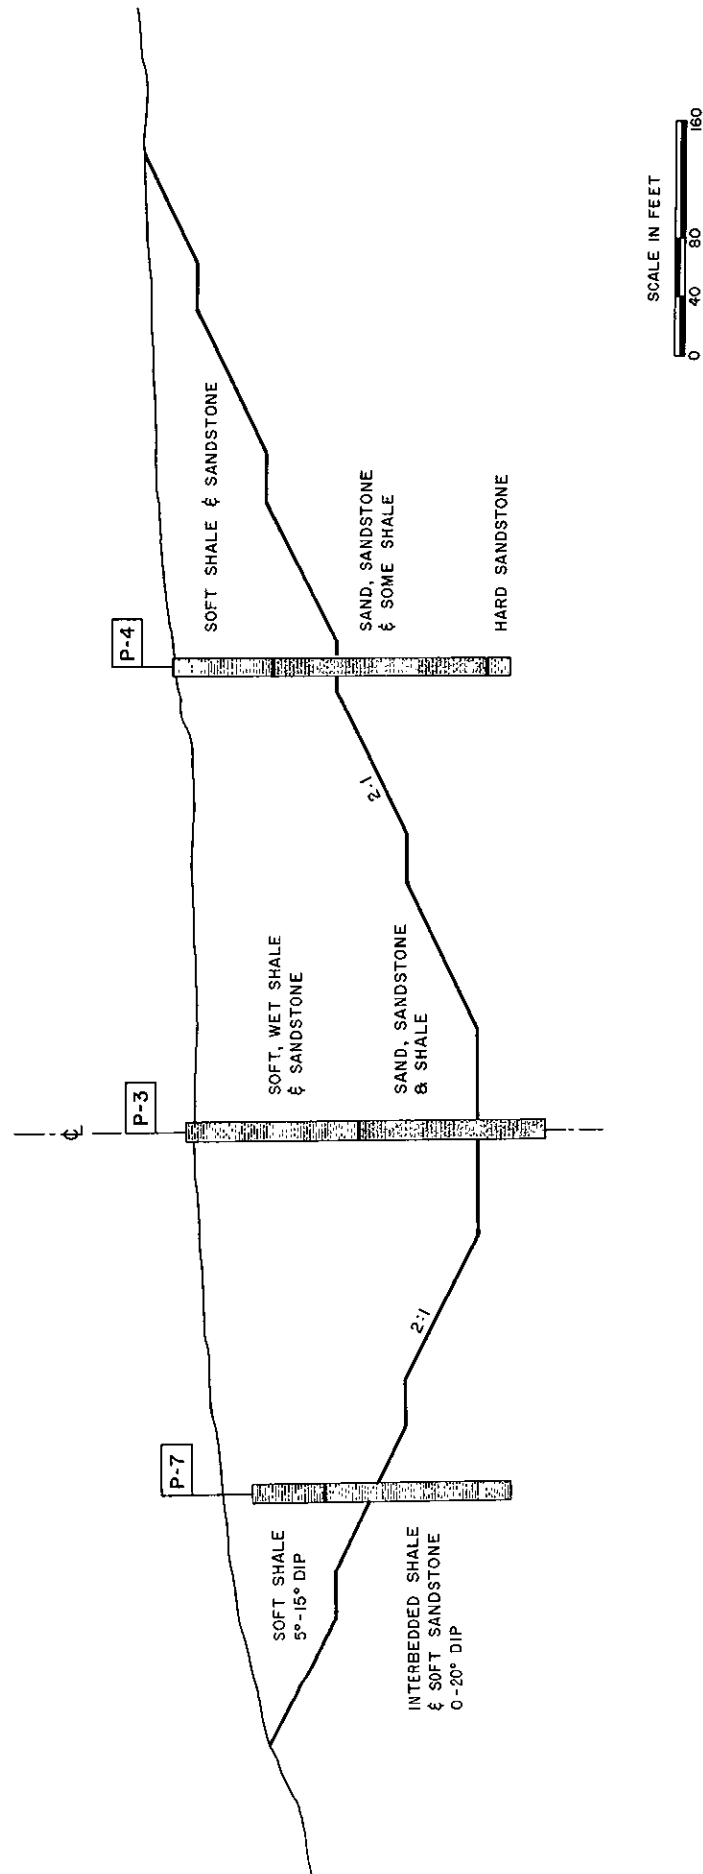
FIG. 7 TYPICAL SECTION OF CARQUEEZ CUT  
WITH SIMPLIFIED BORINGS

On the basis of all available information about the soils and geological conditions in the area, it was determined that this road could be designed on the basis of an open cut through the hill south of the Straits. The typical cross-section reproduced in Fig. 7 shows approximately the maximum section through the cut. The cut was designed with slopes of 2:1 and 30-foot wide benches at 60-foot vertical intervals. This cut was widened about 30 feet on each side at roadway grade to provide protection against the blocking of traffic lanes in the event large slides should take place after the road was opened to traffic. A substantial number of horizontal drains<sup>(5)</sup> were to be installed at various levels in the cut.

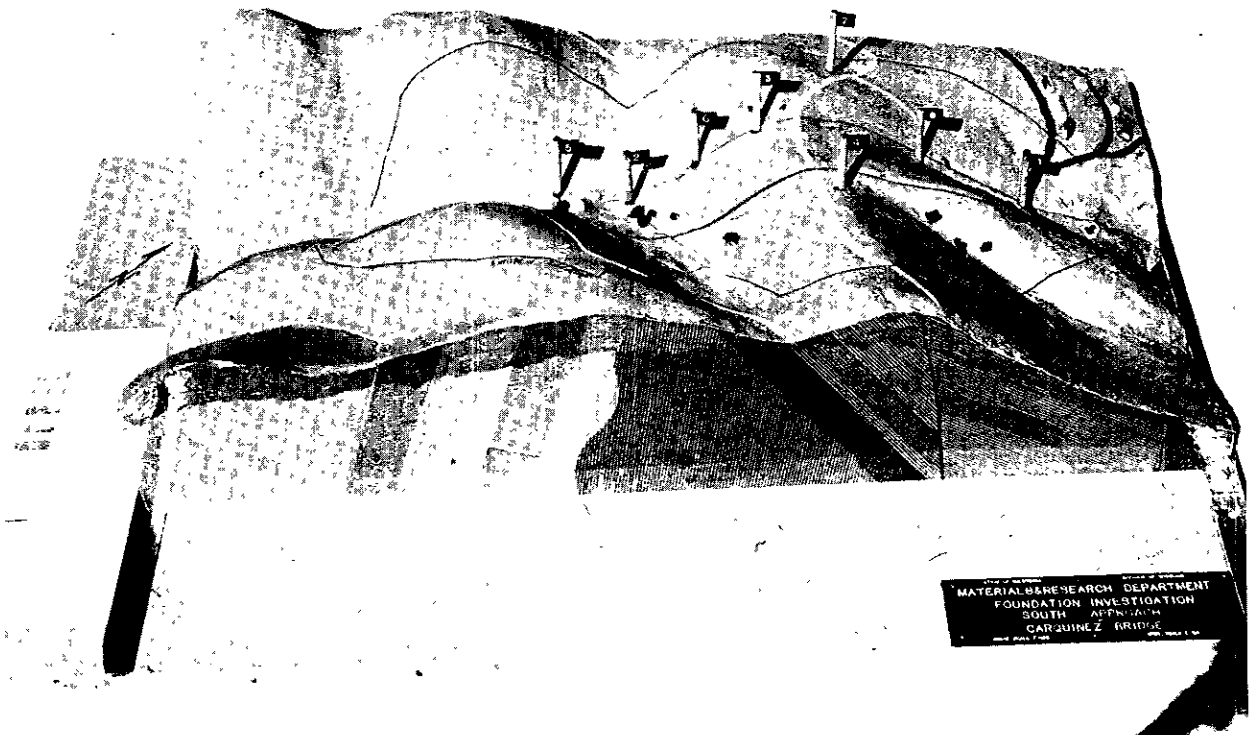
Fig. 8 - View of Model Showing Original Topography  
of Site of Carquinez Cut

deduced and actual geological conditions shown on various surfaces of the model. Photographs of this model are reproduced in Figs. 8 and 9.

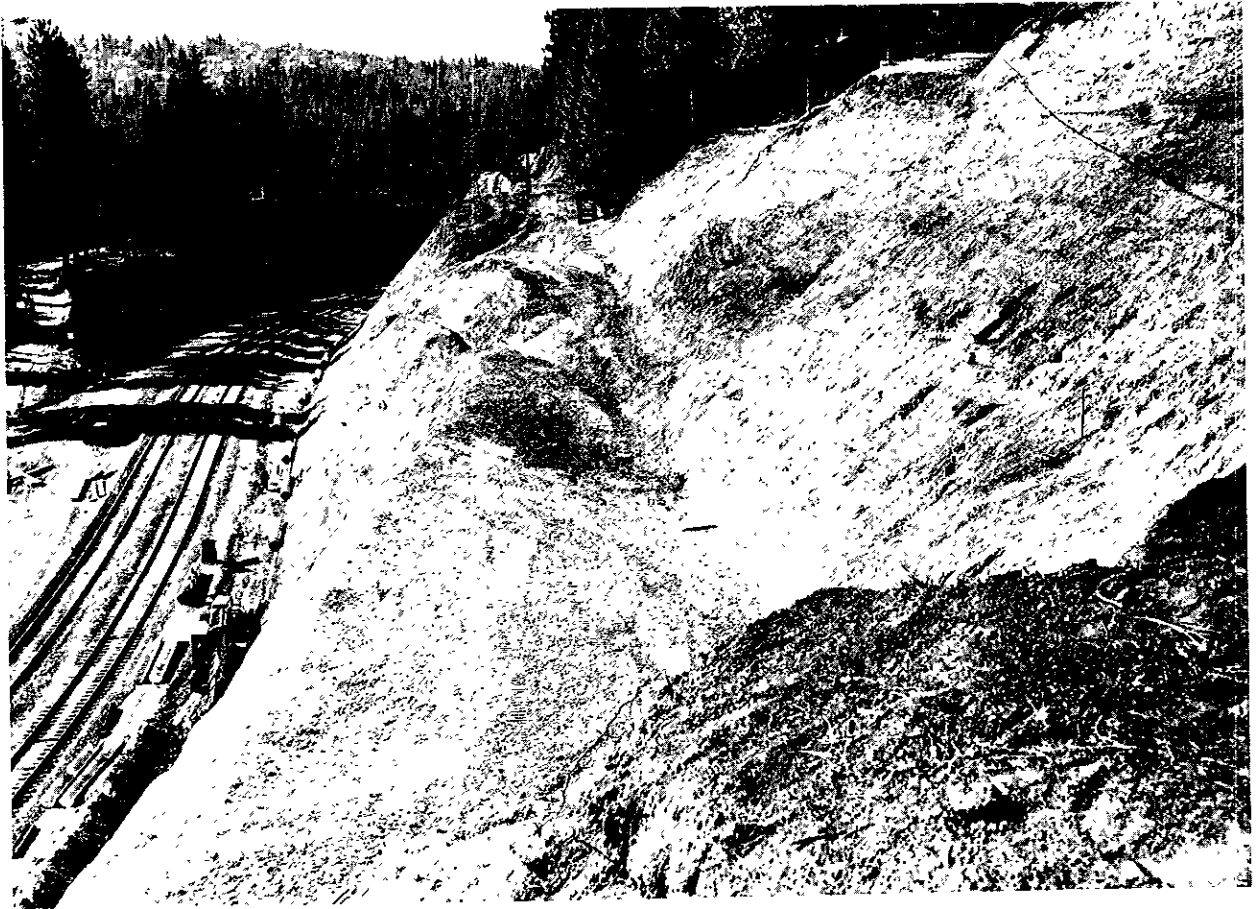
Fig. 17 - View Showing Excavation for Railroad at Towle

In order for the railroad to relocate the tracks and get them back in operation, it was necessary that they do considerable excavation above the tracks in what appeared to be fairly stable terrain. In order to expedite this operation, the excavated material was cast across the tracks into the head of the landslide. It developed that the slope above the tracks was somewhat unstable, and considerable ground water was encountered. Hence, considerably more excavation was necessary than had originally been anticipated. This excavation, when relatively completed, can be seen in Fig. 17. The slide continued to move; and it was necessary that the toe of the slide, as it spilled onto the highway, be excavated as rapidly as possible in order to carry traffic through the area. Traffic was disrupted on the highway for periods of a few hours to several days, and the railroad's operation was seriously curtailed. It should be evident that the operations of wasting excavation into the upper part of the slide and removing debris on the roadway at the toe were certainly not conducive to stabilization of the slide. However, with more favorable weather and completion of the excavation at the upper part of the slide, movement ceased or diminished. Considerable slide removal was done by contract the following summer. This resulted in a further reduction in movement.
